This spreadsheet performs screening level calculations to estimate the effect of peeling leaded paint on the average concentration of lead in yard soil  
**3722 Lafayette Street**

Property ID: 499 (6)	Date: 7-12-05
Address: 3722 LAFAYETTE ST	Telephone #:
Owner:	CO Certification #: 12860
Inspector/Assessor:

## LBP Assessment Results

# Property ID # 499 / 3722 Lafayette

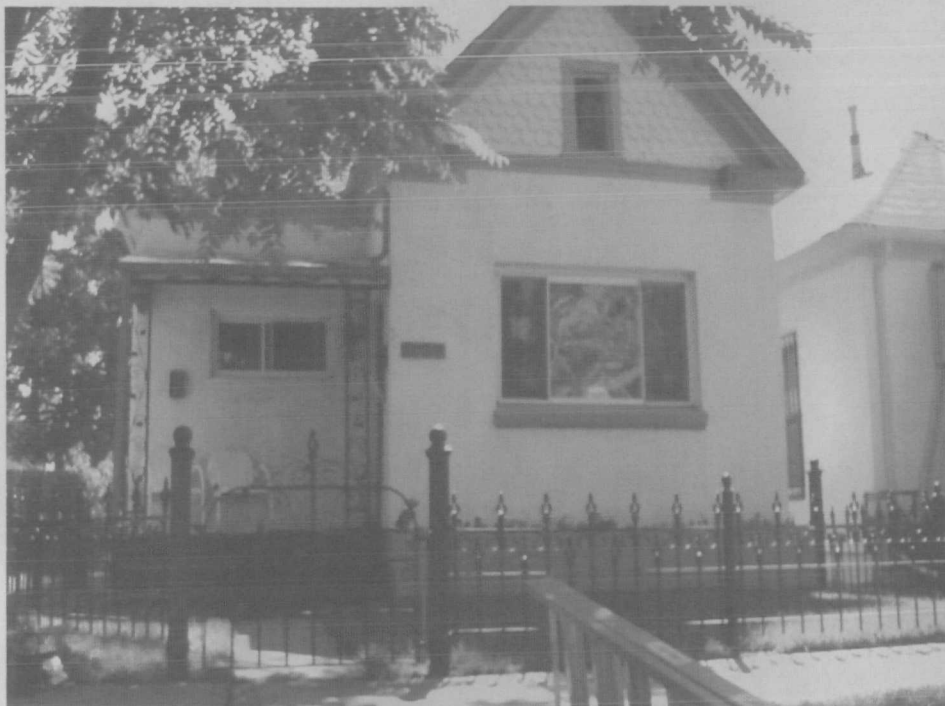
West exposure of property

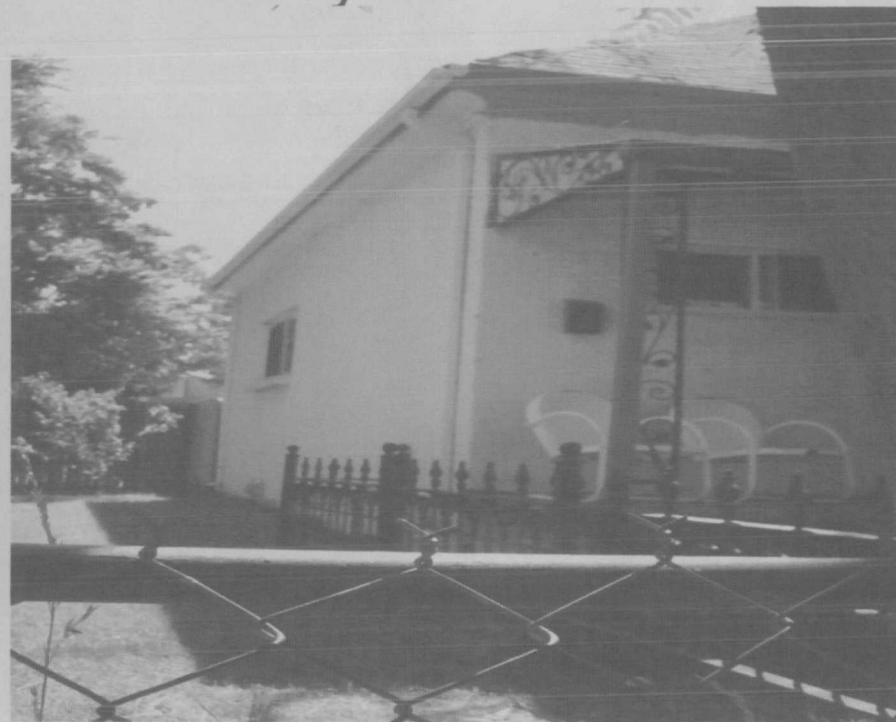
Walls contain lead paint but are in good/ fair condition

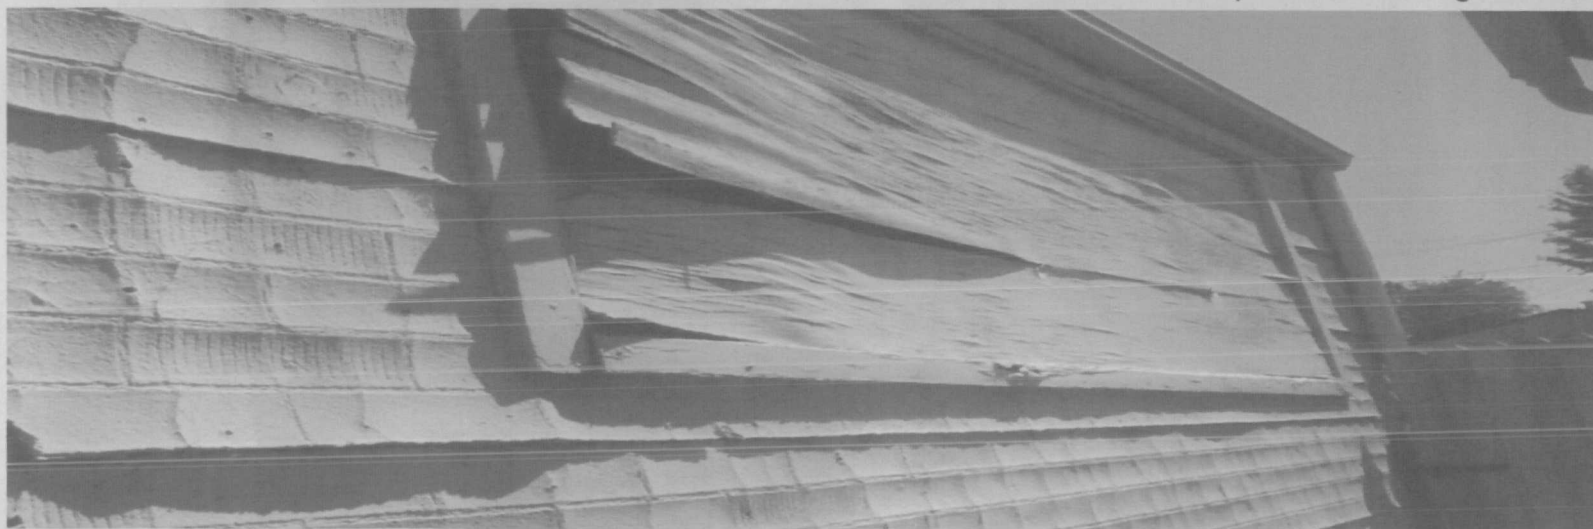
Section of wood siding on south wall contains lead paint & is peeling

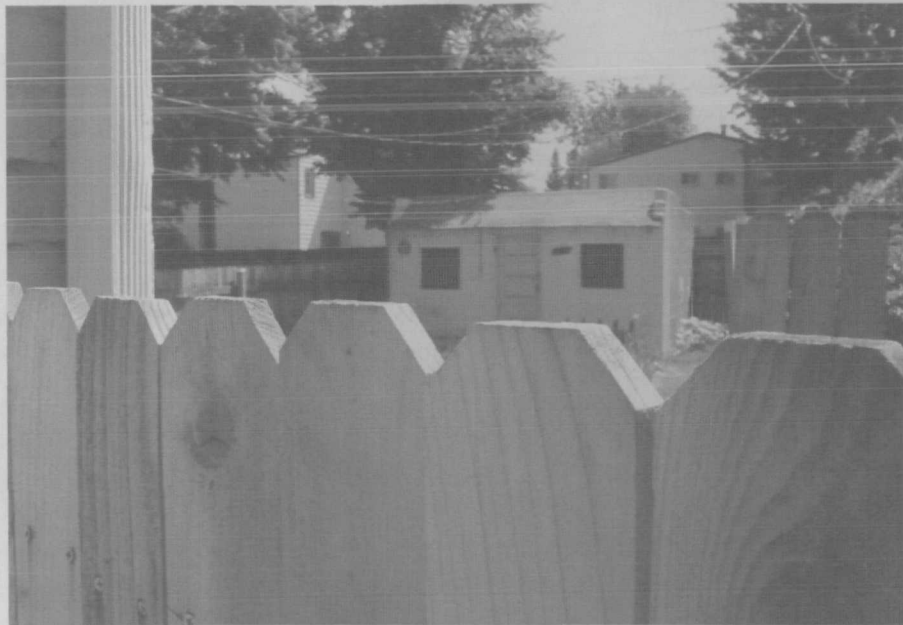
Property # 499: Garage east of house contains lead paint & peeling

Only west exposure of garage is painted

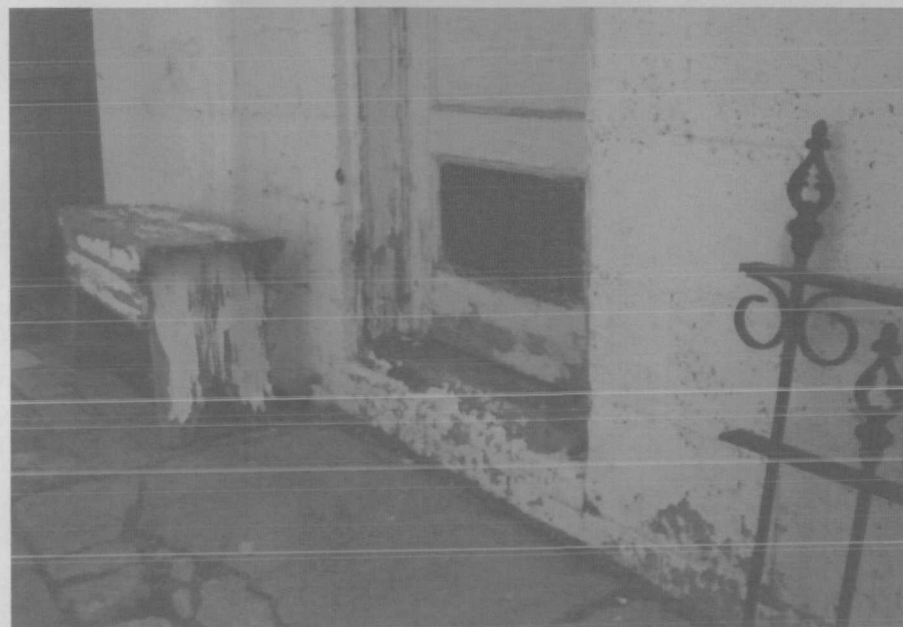
West exposure of garage

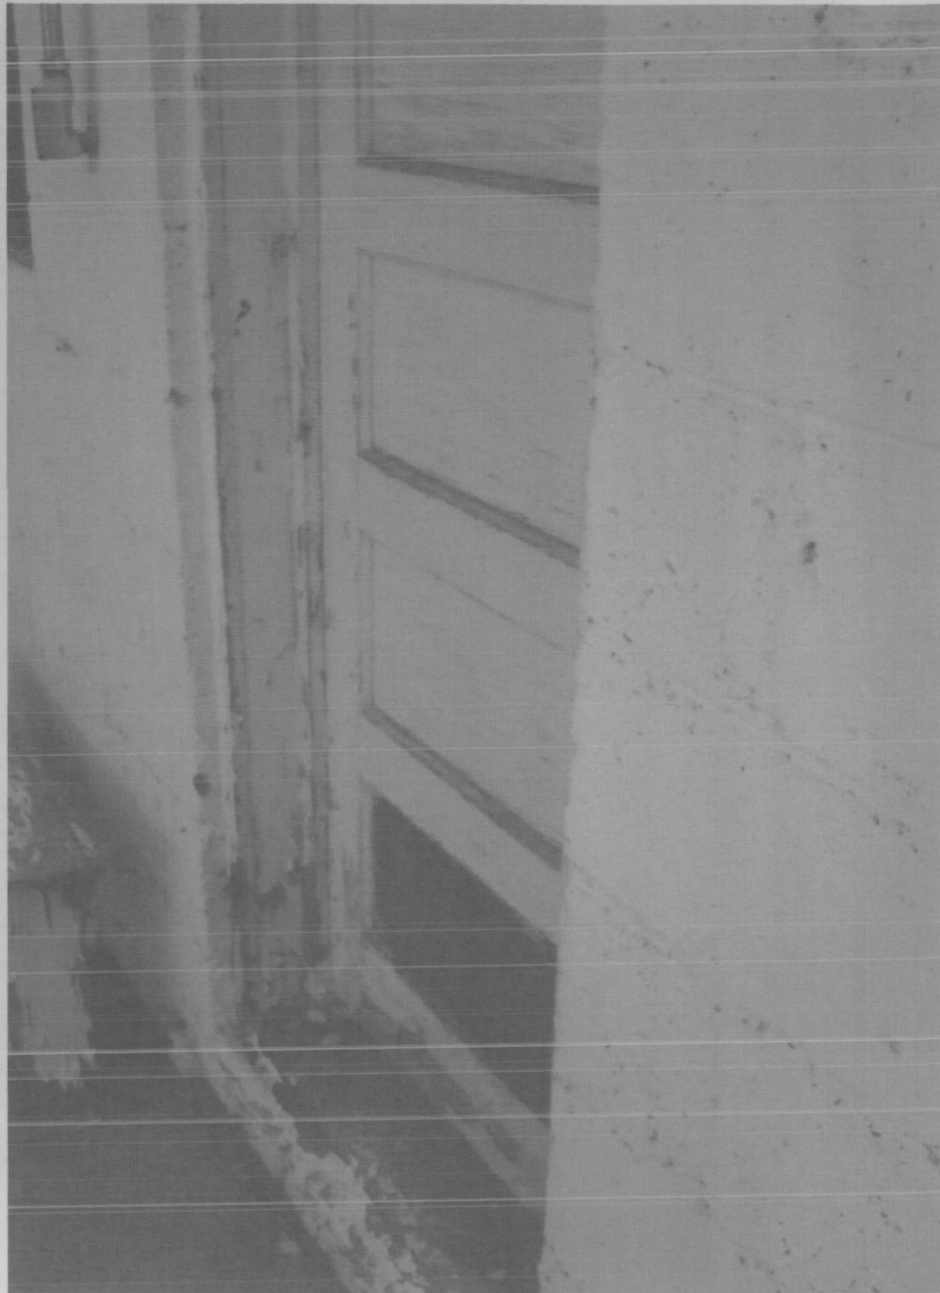
Wall & door contain lead paint
